February 23, 2018

**Re: Ladies' Golf Club of Toronto – 7859 Yonge Street (Ward 1)**

### **Arborist Report – Construction/Tree Protection**

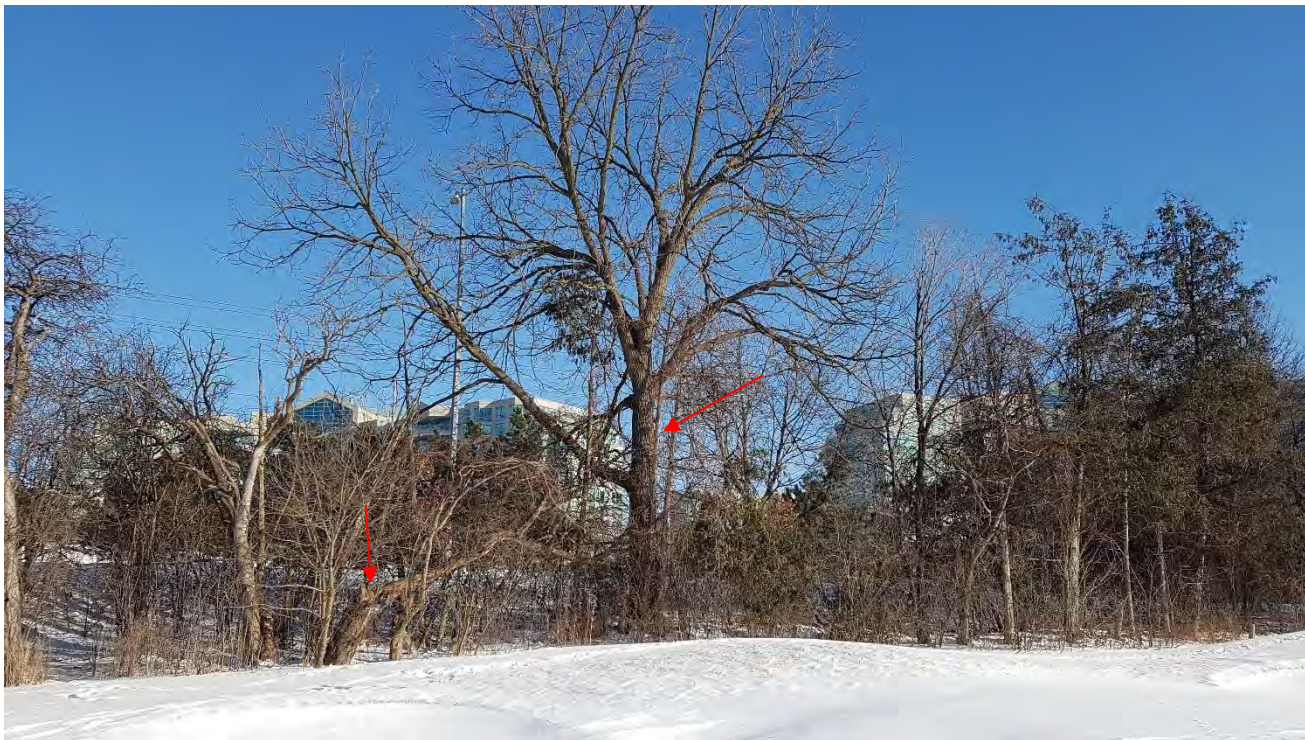
**Photo 3:** Closer view of Trees 512 and 513.

Tree #	Common	Scientific	DBH (cm)	Health	Structure	Dripline (m)	Minimum TPZ (m)	Appraised Value	Category #	Assessment	Comments
513	Crabapple	<i>Malus sp.</i>	~40	Dead	Dead	-	-	-	0	Dead. Failed at 1.5m. Stem is lodged in surrounding trees.	Dead. Requested to be exempt from the bylaw.
513A	N/A	N/A	~30	Dead	Dead	-	-	-	0	Dead. Co-dominant stemmed.	Dead. Requested to be exempt from the bylaw.
514	Crabapple	<i>Malus sp.</i>	42	Poor	Poor	2.5	3.0	\$ 3,110.00	1	Vertical crack from base to 2.5m. Large deadwood throughout.	Requires a <b>permit to remove</b> for new condominium and new hardscape.  Hardscape approaches 1.0m from base.
515	Buckthorn	<i>Rhamnus cathartica</i>	14, 16 (30)	Fair	Fair - Poor	2.0	2.4	-	1	Epicormic growth in canopy. Small deadwood throughout.	Requires a <b>permit to remove</b> for new property fence.  Fence approaches up to base of tree.
516	Ash	<i>Fraxinus sp.</i>	~30	Dead	Dead	-	-	-	0	Dead. EAB.	Dead. Requested to be exempt from the bylaw.

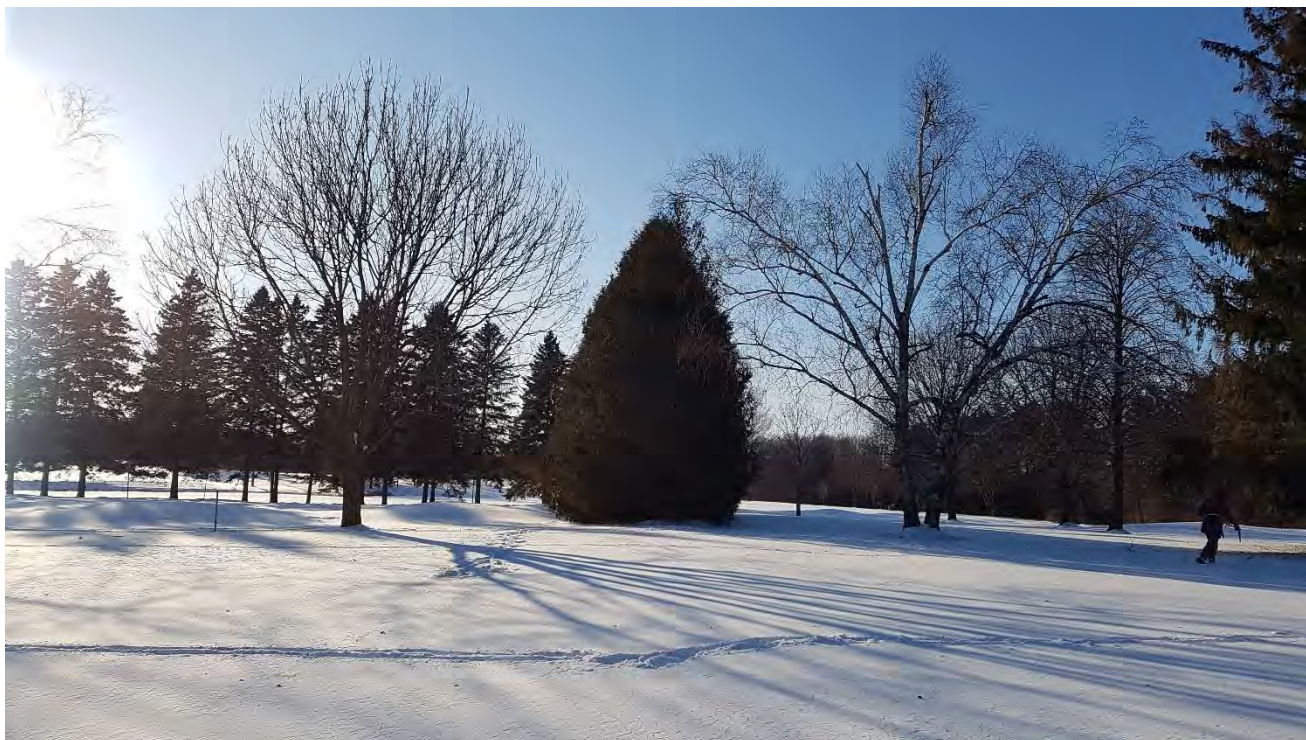
Photo 16: (From right to left) Trees 647, 647A, and 648.

647	Paper Birch	<i>Betula papyrifera</i>	32, 35 (67)	Fair	Fair	3.0	4.2	\$10,800.00	2	Co-dominant stemmed. Cavity on north stem that extend down to grade at approximately 1.5m. 7cm hanger in canopy. Old failures throughout, mainly on the leaders.	Fully protect and to be preserved.
647A	Cedar	<i>Thuja occidentalis</i>	12, 8, 15, 13, 12, 11 (71)	Fair - Good	Fair	2.0	4.8	\$17,500.00	2	Part of a hedge. Slightly sparse. Some small deadwood.	Fully protect and to be preserved.

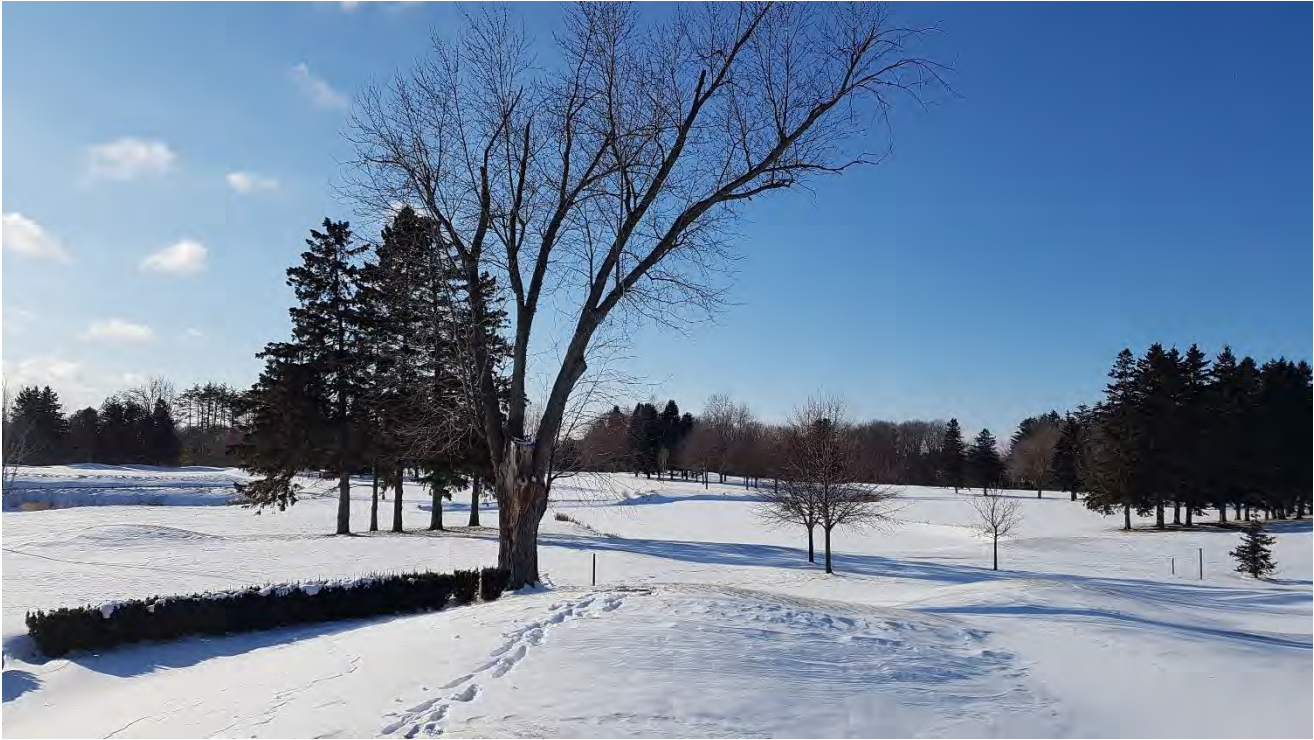
**Photo 19:** (From right to left) Trees 654 - 655.

Tree #	Common	Scientific	DBH (cm)	Health	Structure	Dripline (m)	Minimum TPZ (m)	Appraised Value	Category #	Assessment	Comments
655	Silver Maple	<i>Acer saccharinum</i>	99	Fair - Poor	Poor	7.0	6.0	\$24,000.00	2	32cm cavity on north-west side due to removed stem. Multiple leaders that start at 2.0m above grade. Central stem is 80% dead. South side of trunk is decayed due to 40cm removed stem, and decay extends to grade. Bark is missing in areas of decay along trunk. Old vertical seam near base of tree.	Recommended for a <b>permit to remove</b> based on condition.
656	Norway Maple	<i>Acer platanoides</i>	53	Good	Fair - Good	5.0	3.6	\$18,300.00	1	Basal damage on west side of root flare. Deadwood throughout canopy. Vertical crack on one 15cm limb. 4cm hanger.	Requires a <b>permit to remove</b> for new condominium and underground parking.  Within footprint.
657	Norway Maple	<i>Acer platanoides</i>	52	Good	Fair - Good	5.0	3.6	\$17,000.00	1	Some large deadwood. 3cm hanger. Tight unions.	Requires a <b>permit to remove</b> for new condominium and underground parking.  Within footprint.

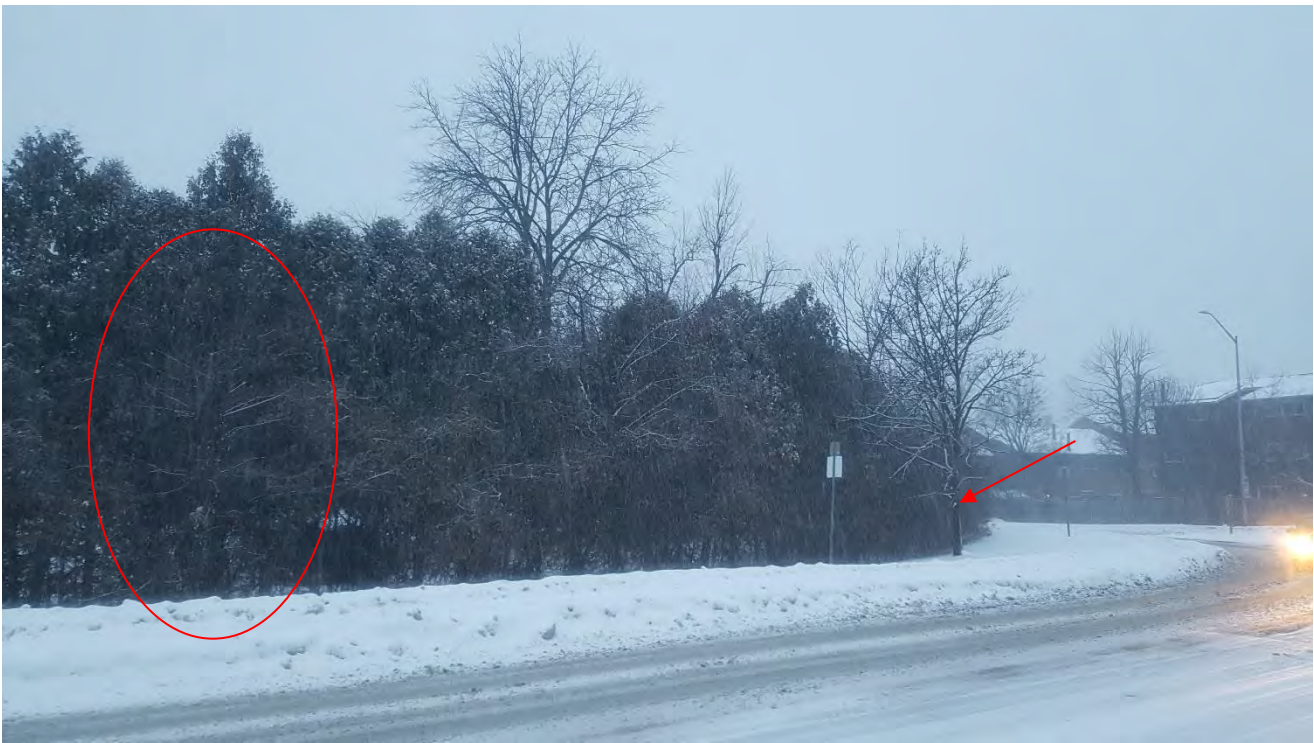
Photo 22: (From right to left) Trees 693C and 693D.

693D	Buckthorn	<i>Rhamnus cathartica</i>	~18	Fair	Fair - Poor	2.0	1.8	\$ 520.00	5	Failed 8cm stem.	Fully protect and to be preserved.

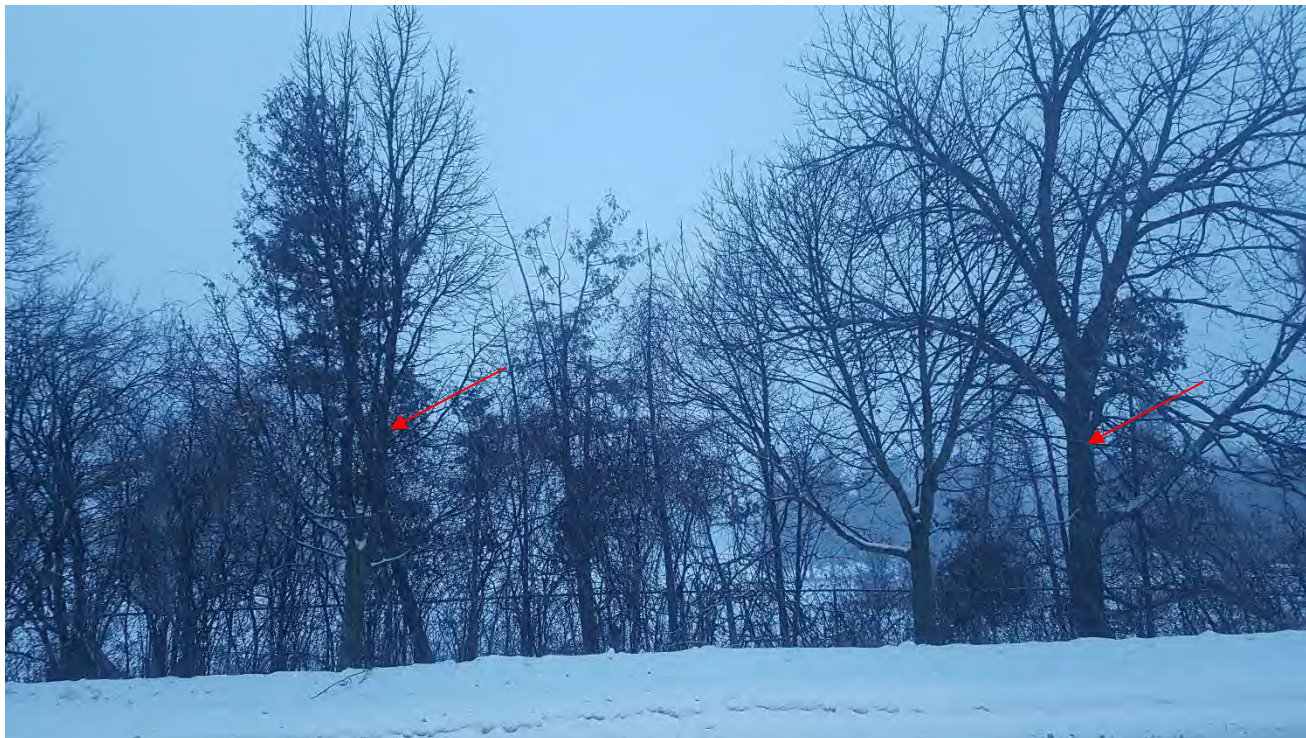
Photo x: (From right to left) Trees 693J and 693K.

693J	Norway Maple	<i>Acer platanoides</i>	30	Fair - Good	Fair - Good	3.0	2.4	\$ 6,200.00	5	Some small deadwood. Interference from nearby trees.	Fully protect and to be preserved.
693K	Norway Maple	<i>Acer platanoides</i>	28	Fair	Fair	2.5	2.4	\$ 4,310.00	5	Co-dominant stemmed. Possible columnar variety. Stunted bud progression.	Fully protect and to be preserved.
693L	Norway Maple	<i>Acer platanoides</i>	38	Fair - Good	Fair	3.5	2.4	\$ 8,900.00	5	Co-dominant stemmed with an included union. Some epicormic growth.	Fully protect and to be preserved.
693M	Norway Maple	<i>Acer platanoides</i>	36	Good	Fair - Good	3.5	2.4	\$ 8,900.00	5	Co-dominant stemmed. 3cm hanger.	Fully protect and to be preserved.
